Name of Dam: Beatties Millpond Dam

Location: Hanover County, State of Virginia

Inventory Number: VA 08535

PHASE I INSPECTION REPORT NATIONAL DAM SAFETY PROGRAM

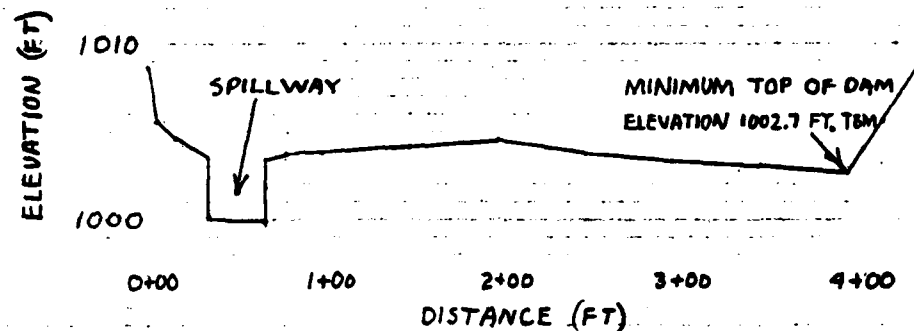
TOP OF DAM PROFILE LOOKING DOWNSTREAM

VISUAL EXAMINATION OF	OBSERVATIONS	REMARKS OR RECOMMENDATIONS
VERTICAL AND HORIZONTAL ALIGNMENT OF THE CREST	<p>The dam has a downstream curvature. The crest of the dam varies vertically about 1.5 ft. with the lowest area near the right abutment. No significant horizontal misalignment was observed. The grass covered crest is about 16 ft. wide.</p>

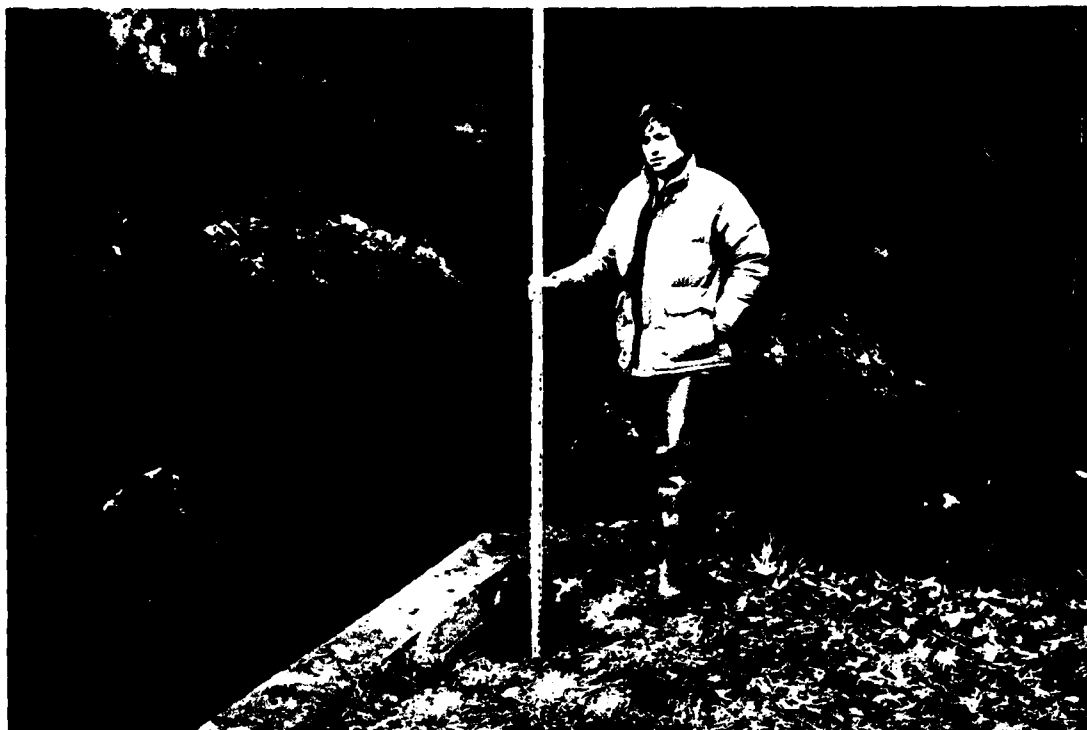
PHOTO 5. Hole Behind Right Training Wall

Rebuild the foundations under the wing and training walls as described above. Backfill, compact, and seed the eroded and slumped areas. This area should be inspected on a regular basis to monitor signs of renewed seepage. The seepage from the hillside downstream from the right abutment should be redirected toward the downstream area away from the toe.
